- #1 PAYOFF REEL MANDREL FAILURE -

July 1, 2006

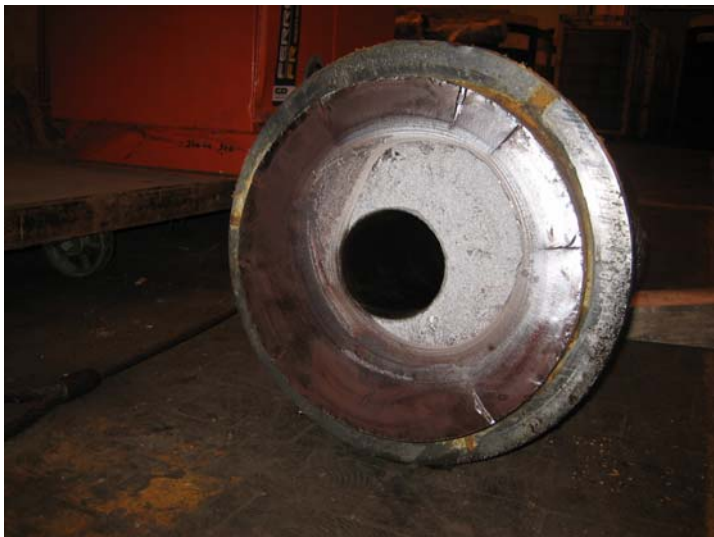
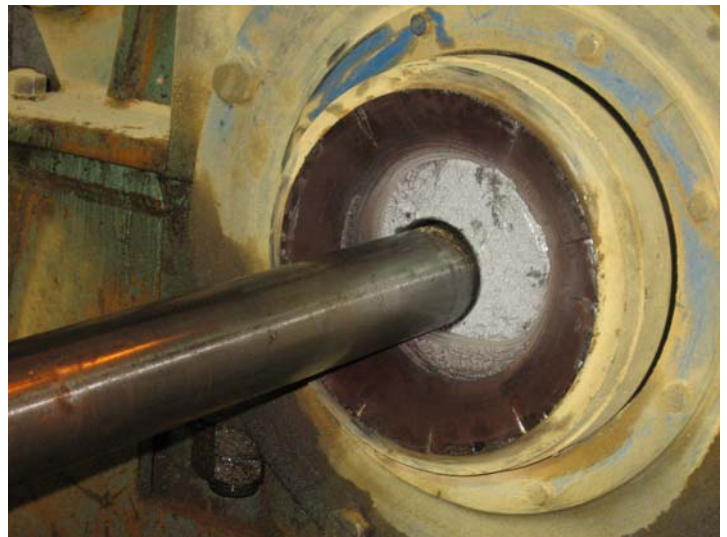
The failure is shown below. Both photographs show the same pattern. The outermost elements of the shaft have some discoloration from light corrosion indicating prolonged exposure to the elements. That indicates that some cracking may have been evident for some time. The outer part of that discolored area has no rough edges and the ring pattern such as seen in the inner, more recent portion. The outer portion has been rubbed clean by the relative motion of the two portions of the shaft.

The brighter spot on the interior is a brittle fracture where the shaft finally let loose. There is a scar where on both parts where a chunk may have been dragged as the parts separated.

In the case of the mandrel shaft, the crack propagation appears to have stopped at the hole. The outermost portions of the cracking area have been rubbed down so that no sharp edges remain.

The broken mandrel was replaced with a built up spare. The 'built up' spare already had bearing cartridges and the hydraulic actuator installed. Unfortunately, the outboard bearing cartridge, the one furthest from the head, was installed incorrectly on the spare. The cartridge has an offset groove and holes for oil flow. It was installed backwards on this mandrel so that the oil flow would've been restricted.

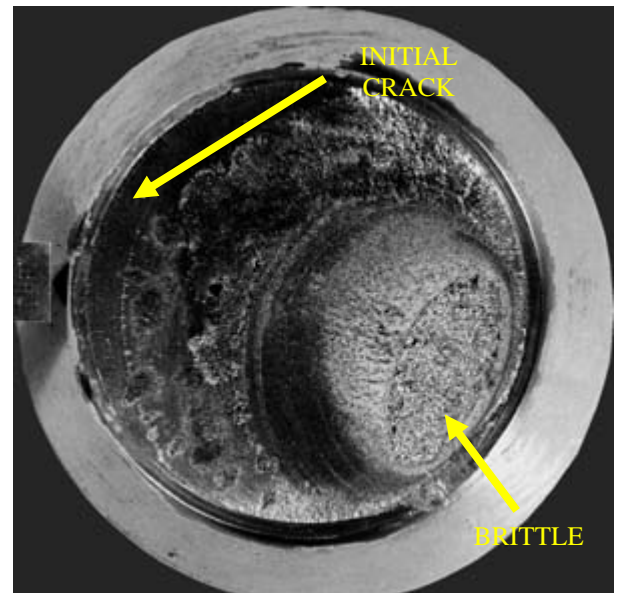
As a point of comparison, the picture shown here is a typical fatigue failure purposely produced for testing. It is right at a shoulder in the shaft. Shoulders and nicks produce what are called stress concentrations. These concentrations can raise the amount of stress on a small portion of steel by 2 or 3 times or more. If the shaft isn't properly designed, is overloaded or if the machining quality is poor then shoulders and nicks are often where fatigue failures will start.

This is typical of a shafting fatigue failure. Note the similarities to the mandrel failure. The large zone on the left where the cracking began and gradually worked across the face followed by a brittle area in the lower right where the shaft finally snapped. The initial crack was at about 10:00 and it gradually worked its way across the shaft until there wasn't enough metal to support the load. The shaft then broke as indicated by the oval in the lower right.

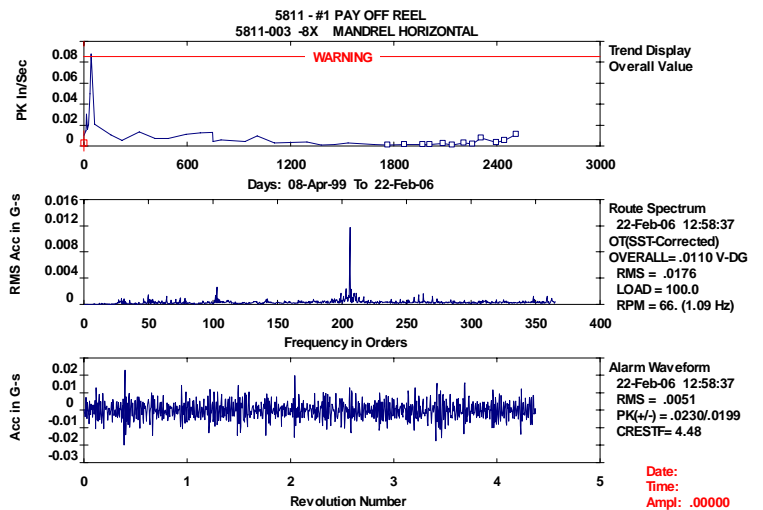
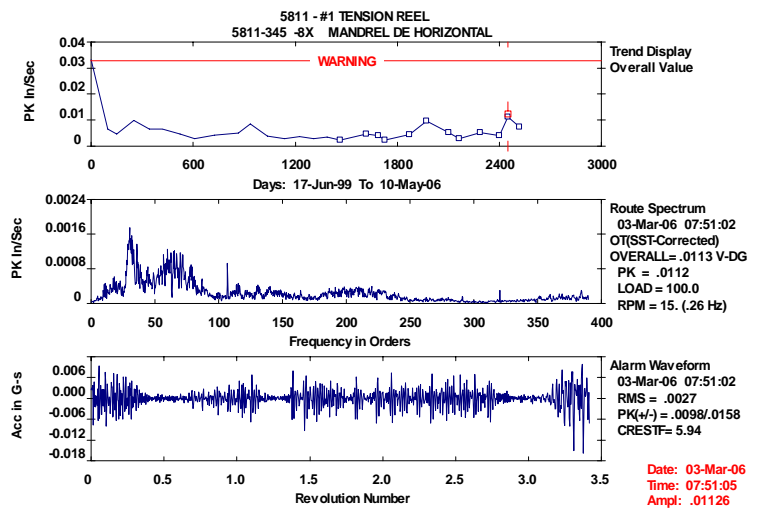
The top plot shows the latest vibration data for the bearing closest to the failure. The spikes in the time waveform (bottom) may have been due to the fatigue cracking but were attributed to the stiction. The bottom plot is from Tension Reel #1. Note how a similar pattern exists here.

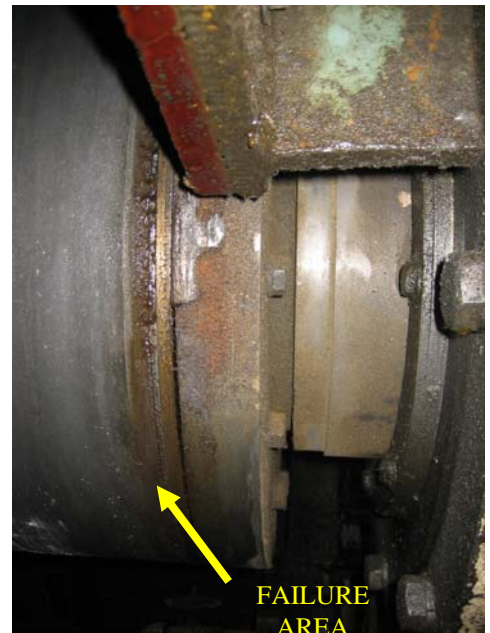
A simple visual inspection was unlikely to identify any problem. Most of the mandrel shaft is enclosed in either the gear case or under the reel head. The failed area is near the only exposed portion, but still behind

This picture shows the area that failed on the sister reel. The actual failure took place on the shaft to the left of the head clamping plate in the center. As can be seen (or not) this area is inaccessible to simple inspection.

Ultrasonic crack inspection should be performed on the other reels on a semi-annual basis. This should be adequate to identify any problems before they result in a similar failure.

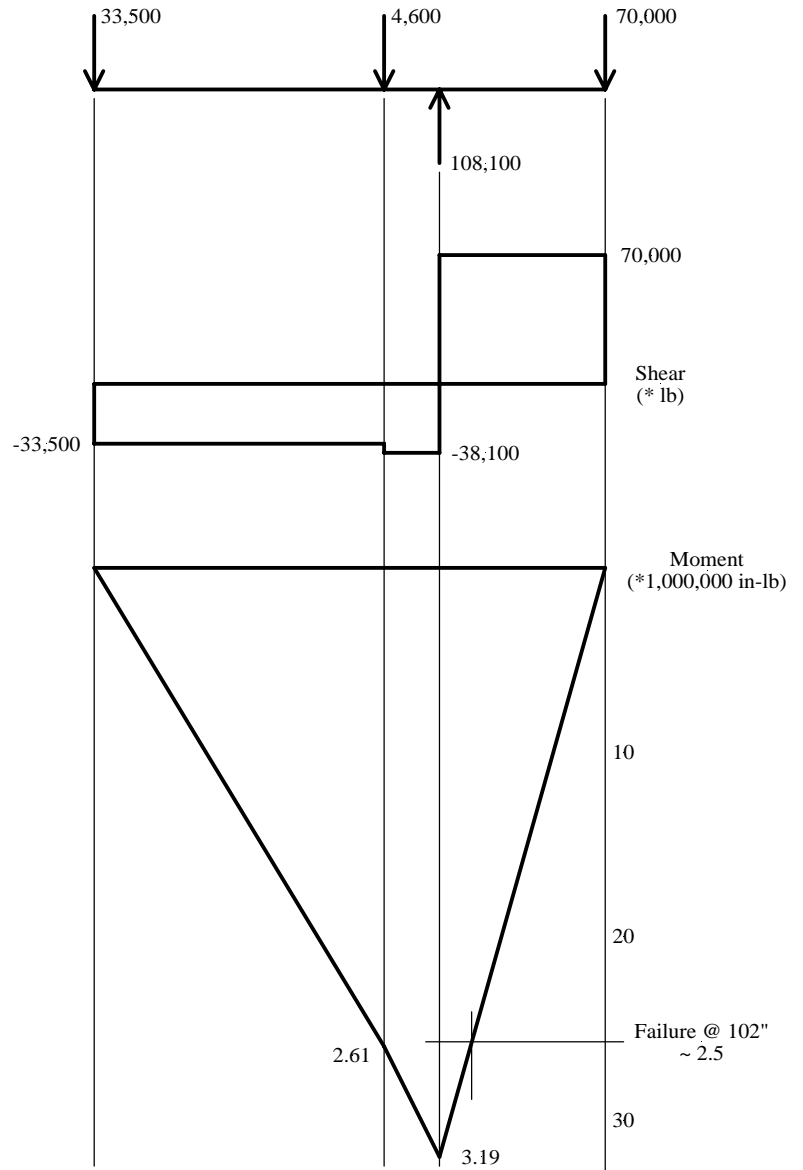
Determine the moment at the failure point, 102 inches from the left end.

Graphically gives confidence that the failure occurred near the point of greatest bending stress. It is notable that the failure also occurred at the smallest section in this area.

Graphically the moment at the failure point is about:

$$M_{102''} = 2.5 (10^6) \text{ in-lb}$$

$$\sigma = \frac{M}{I/c} = \frac{2,500,000 \text{ in-lb}}{203 \text{ in}^3} = 12,300 \text{ psi}$$

the mandrel design is susceptible to fatigue failure.

Other mandrels of this design should be checked for signs of fatigue damage. A periodic testing program should be established.
