**To:**  
**From:** D. K. Smithman  
**Subject:** B Pusher Failure Report  
**Date:** December 12, 2003

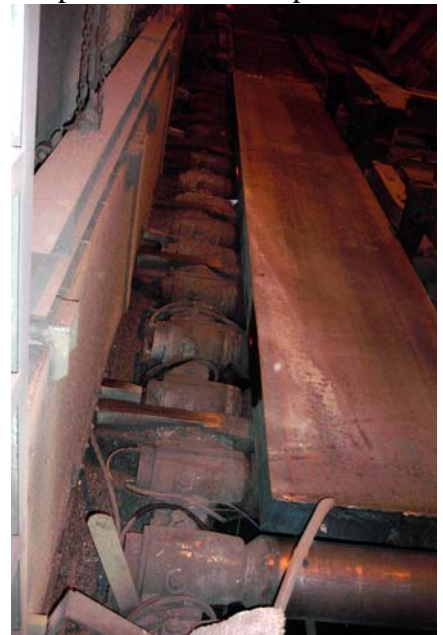
During a motor failure incident on 12/30/03, it was noted that the bar was not impeded by any bearing housings or other hardware. (See photo).

Since nothing is stopping the bar and higher amps are being drawn on all bars, this points to some sort of binding in the pusher arms or in the gearbox.

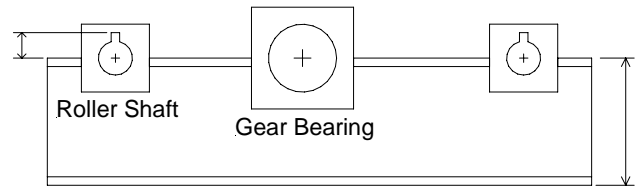
3. The drawings show that the support rollers and the spur gear centerlines are located from two different surfaces in the fabricated housing. This is poor design practice for two reasons. Locating critical dimensions from more than one surface allows for tolerance accumulation. Also, the location of these two un-machined surfaces is not well controlled since there is no reason to do so.

4. The drawings show that the spur gear outer diameter was reduced from 10.415" to 10.3044" five months after the drawing was originally issued.
5. I suspect that the drawing was changed after a pre-delivery assembly test identified interference problems created by the poor dimensioning of the foundation.

Bottom Line: The interference in the rack and pinion on both B pusher arms needs to be evaluated. Clean the teeth and inspect as well as possible. Bluing the teeth and running may give some insight as to the location of the pitch line (point of load transmission). Also, consider using plastigage to determine the depth of the root clearance. However, making firm measurements to the accuracy of 0.1" required may force disassembly.

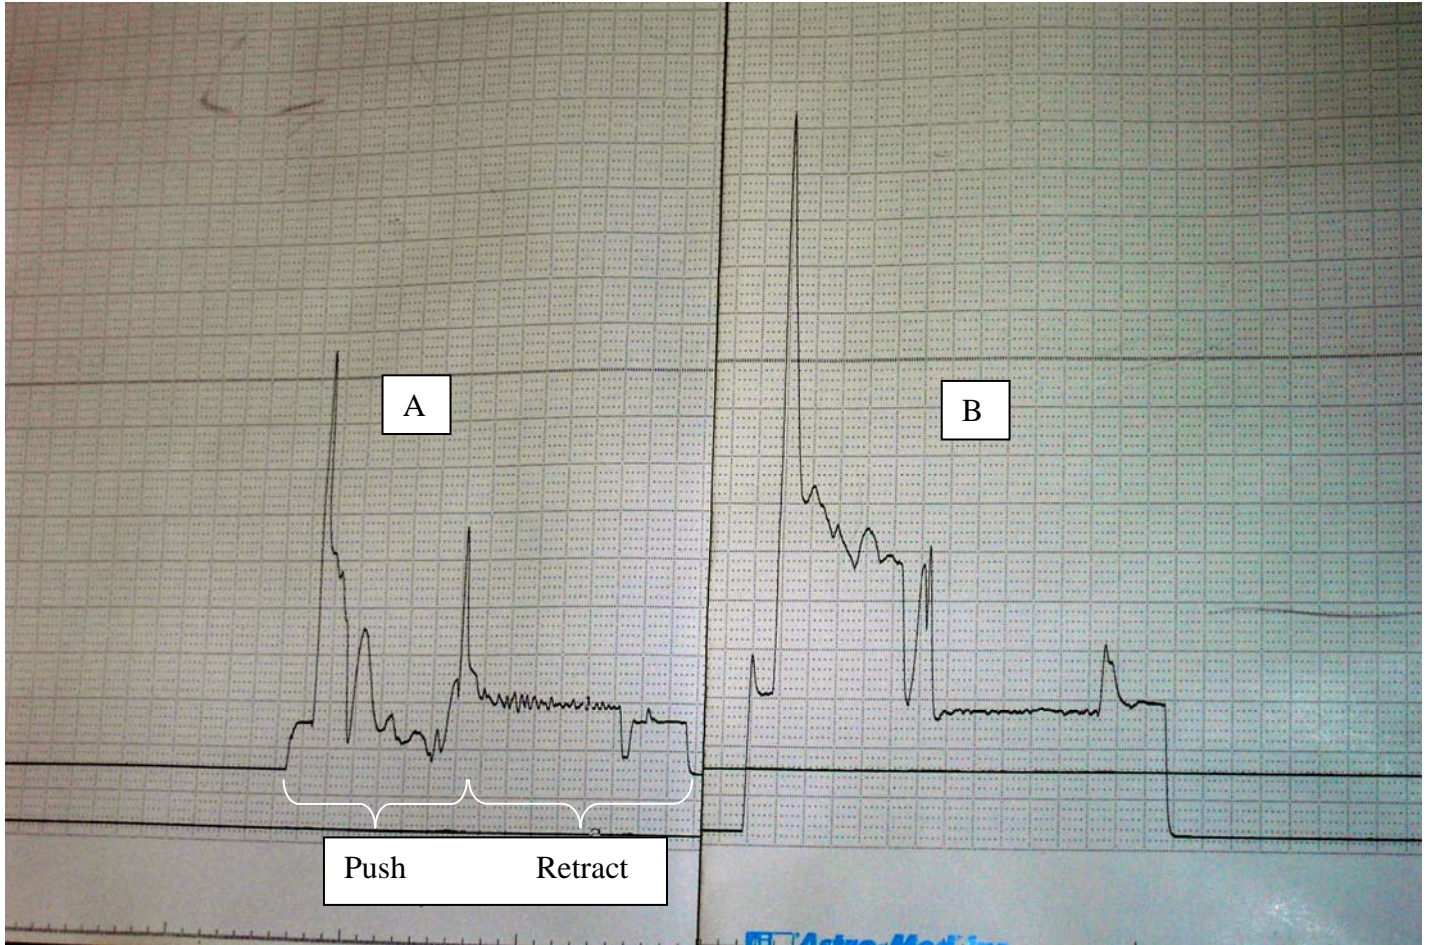
1. Current measurements show that B draws more current than A but that this is most prominent during the pushing portion of the cycle. (See attached graph).

Current traces pushing in 25 ton bars. Note the elevated current on B during the push phase.

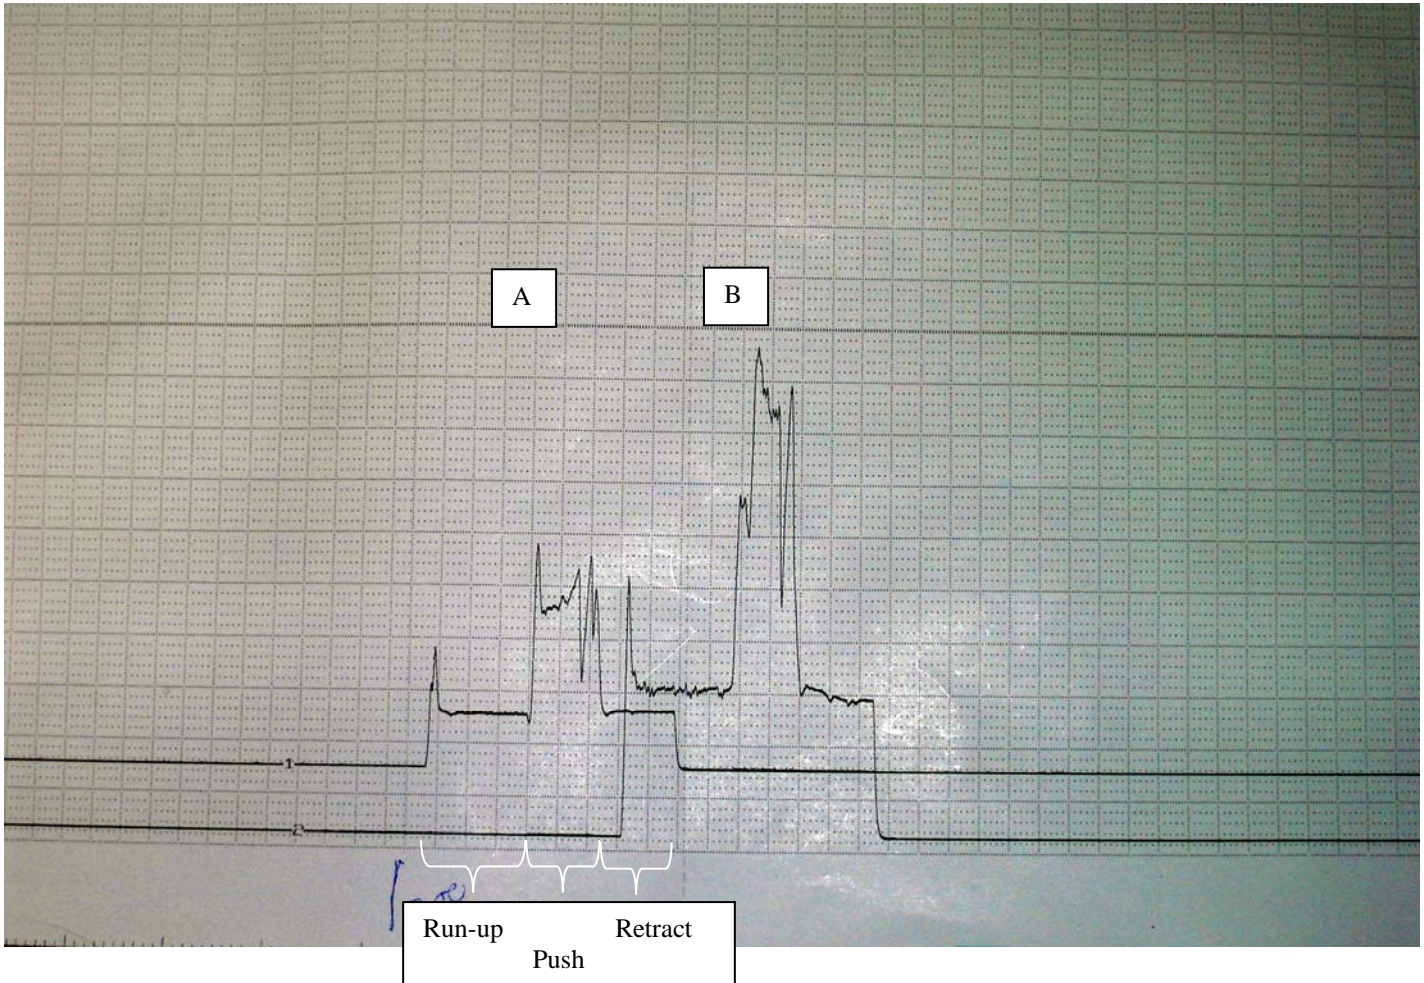
2. Current measurements made without a bar and during the push to the measure position show higher current draws on B than on A when the system isn't loaded. This indicates additional load from the mechanism. (See attached graph).

Current traces putting 26 ton bars in the 'measure' position. These are similar to the no-bar tests but the traces are less jumbled. They show that B has higher current during run-up and retract than A.
