To:
From: D. Smithman
Subject: F10 Drive Failure
Date: January 17, 2005

The drive on Finishing Mill Stand 10 failed on January 16, 2005 resulting in approximately 17 hours of lost production availability. The problem was found to be a worn belt which was replaced.

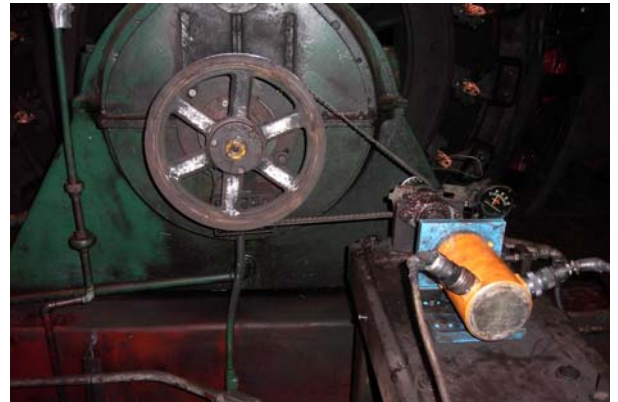
While changing the resolver, some calculations were made to try to determine a cause for a 0.74 times per revolution phenomena. The speed ratio as determined to be the pulley sizes for the resolver shaft was $15.5/3.25=4.77$. This didn't provide any obvious connection. Next, the speed of the resolver belt was checked using 1 for the armature speed so as to normalize the result.

$$f = \frac{\pi * rpm_{pulley} * dia_{pulley}}{length_{belt}} = \frac{\pi * 1 * 15.5}{64} = 0.76$$

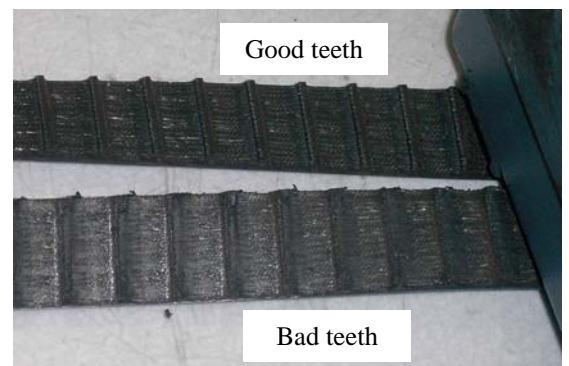
The old belt was found to have several damaged teeth in one area. Note the gouged areas on the right of the bottom teeth. This allowed the belt to slip and resulted in a false mill speed reference for the stand control system. The system was compensating for this by trying to speed up the motor once every $\frac{3}{4}$ of a revolution resulting in the high current and pulsating sparking.

This provided a good match with the pulsing frequency, i.e., 0.74 is very close to 0.76, so the resolver belt was replaced. The pulsing ended and the motor currents went back to more historically reasonable values.
