To:
From: D. Smithman
Subject: Progress Report – Motor & Generator Issues
Date: June 6, 2008

This is a progress report concerning major motor & generator work underway or being considered for the ABC Company. Changes are in *italics*.

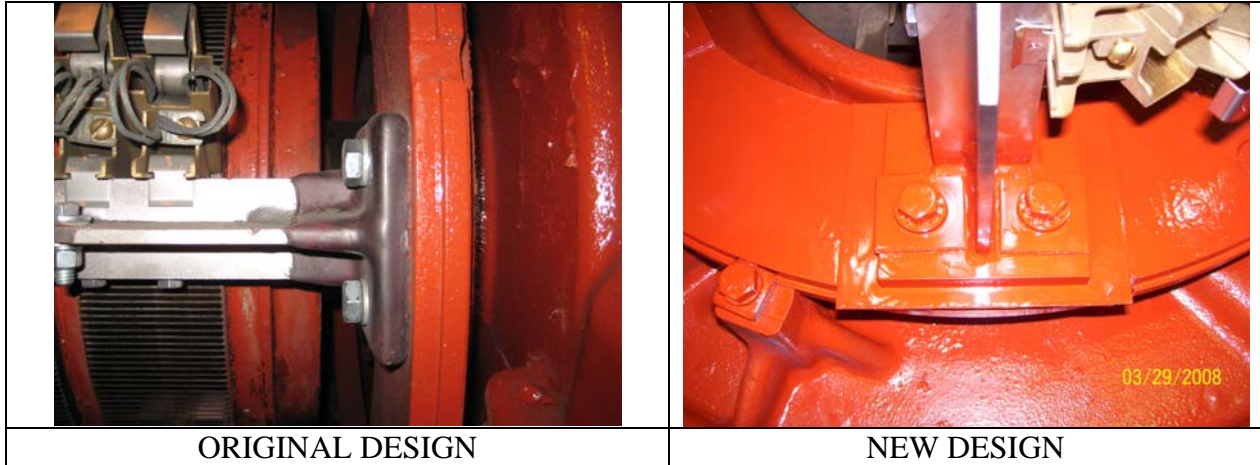
Subject: 5TS TENSION REEL MOTOR REPAIR-BRUSH ARM ISOLATION

Comments: The GE design for this motor included a hardened rubber coating on the brush arms that provided electrical isolation. Several of these arms were missing from the spare motor and had to be scavenged from the failed motor. Replacements were very expensive due to the rubber coating so the isolation was re-designed by Hannon and new arms were fabricated. The isolation consists of a micarta backing plate, micarta bushings over the threads and micarta washers under the nuts.

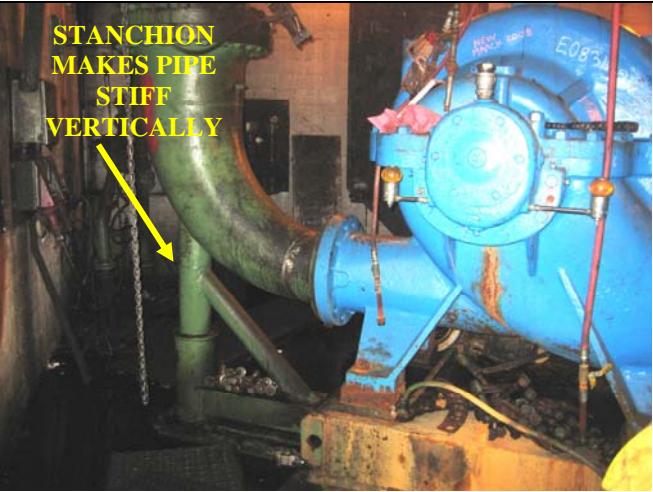
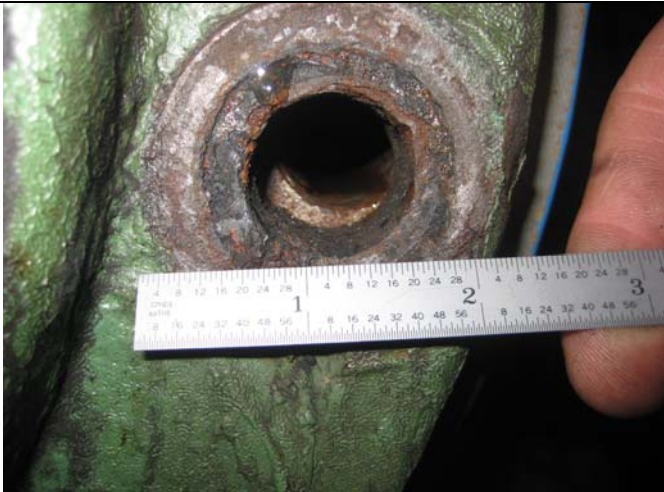
RECIRC SUCTION PIPE	RADIAL MISALIGNMENT

COMMENTS: The suction flange bolts were removed and the pipe misalignment inspected as the pump was being changed. Misalignment was 1/8 to 3/16 inches radially and axially. The pump shaft motion relative to the motor shaft was measured as the flange bolts were loosened. There was significant motion although the amount is about the same as misalignment tolerances. The cumulative affect of this, thermal expansion and alignment tolerance may be enough to cause some trouble but this isn't definitive proof. RAM is concerned with internal distortion but the bearing supports are stiff enough relative to their supports that this doesn't seem likely.
