- #1 PAYOFF REEL MANDREL FAILURE -

July 1, 2006

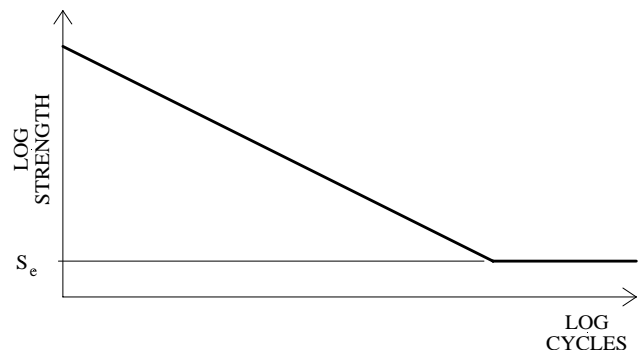
$$\begin{aligned} S_e &= 0.72(0.75)(0.81)(1.00)(0.34)(62,500) \\ &= \underline{\underline{9,300 \text{ psi}}} \end{aligned}$$

This is the endurance limit, the ‘knee’ in the S-N diagram. If the operating stress is greater than this value then fatigue will become a concern.

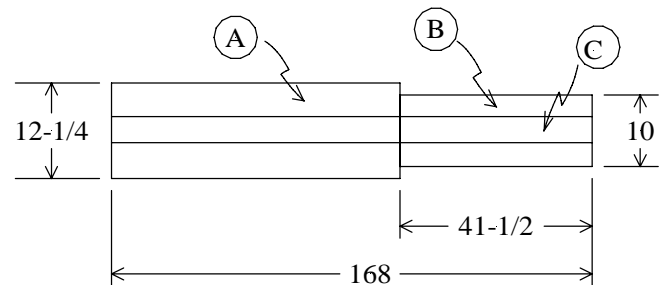
Round the weight to 4600 lb

$$\frac{63.25(4400) + 147.25(923)}{(4400 + 923)} = 77.8in$$

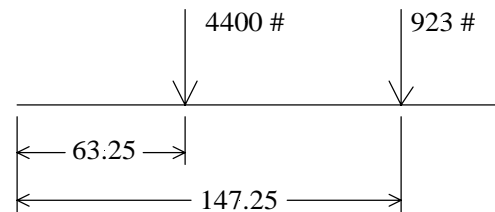
Determine the bearing reactions

$$R_L = 74,600 - 108,100 \text{ (from moment calc)}$$

$$R_L = -33,500 \text{ lb (and is acting DOWN)}$$

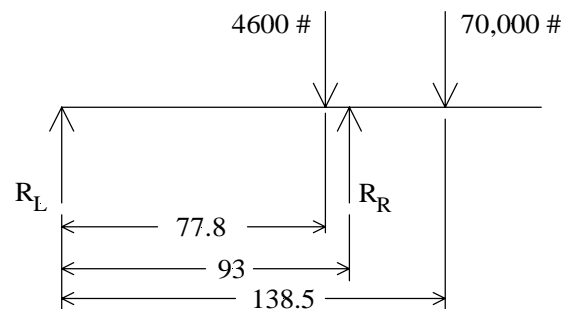
$$\Sigma M_L = 0 \text{ (CCW is positive)}$$

$$-4600(77.8) + 93R_R - 138.5(70,000) = 0$$

Determine the moment at the failure point, 102 inches from the left end.

Graphically gives confidence that the failure occurred near the point of greatest bending stress. It is notable that the failure also occurred at the smallest section in this area.
